S.B. Riparian Canopy Coverage: Comparing Restored, Non-Urban, and Urban Sites

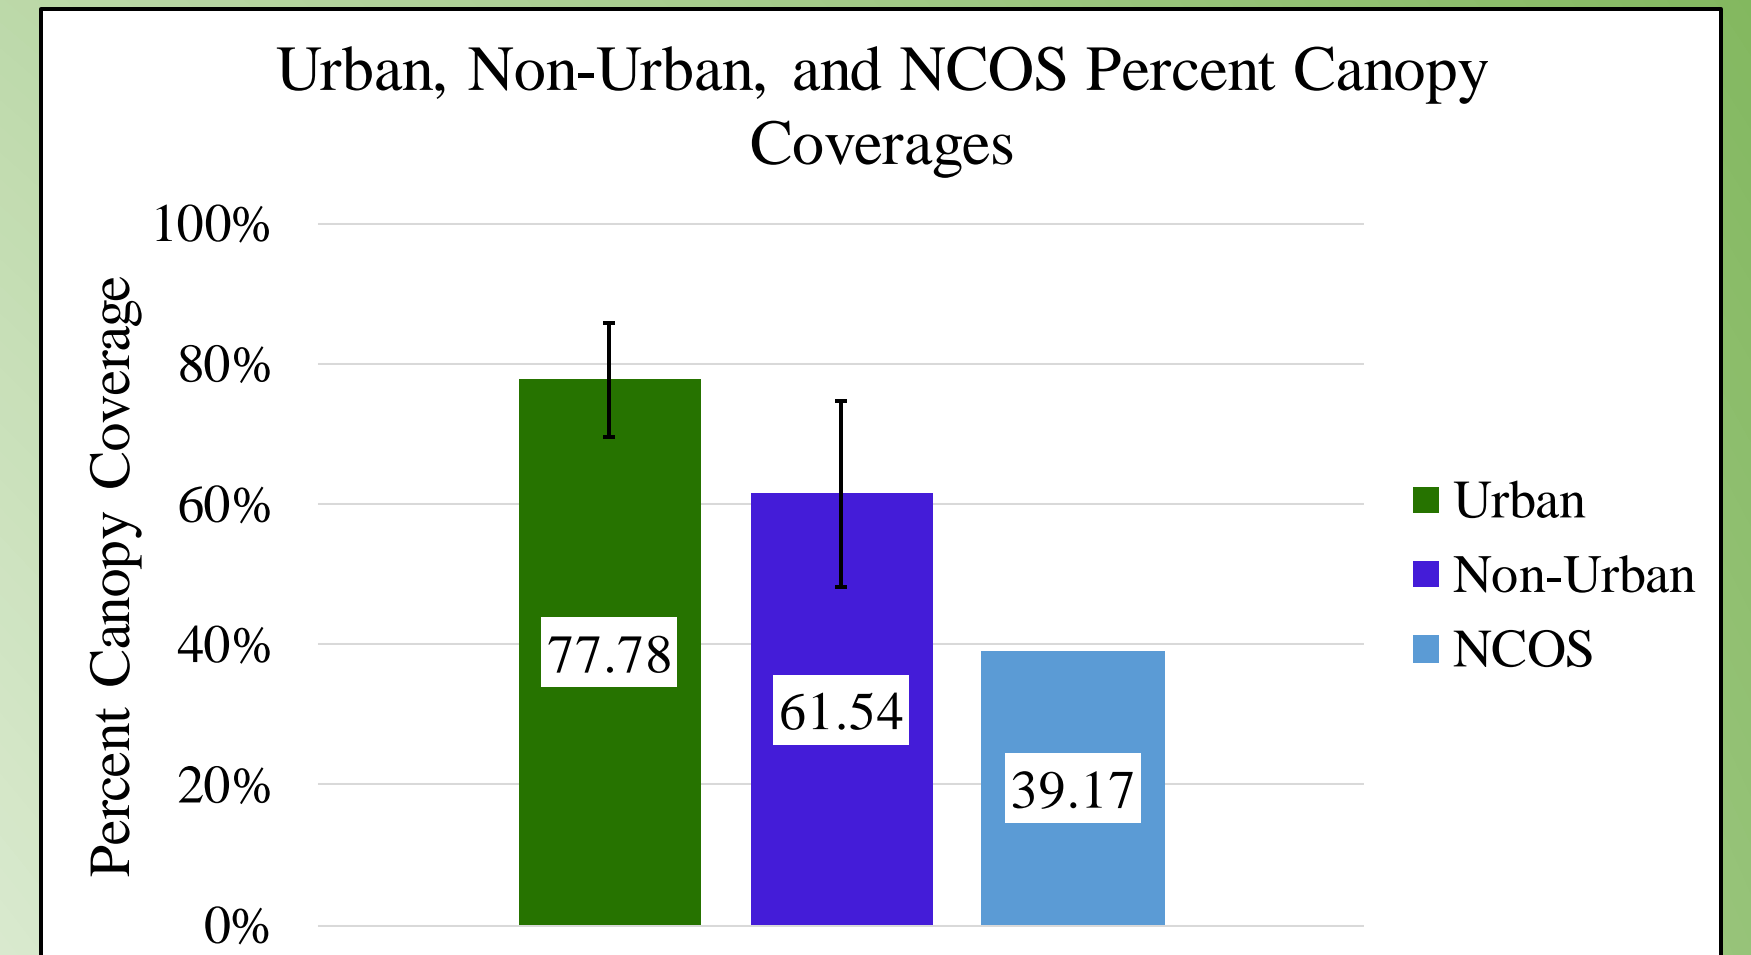
The bar graph depicts the mean PCC per site type. The mean PCC for urban sites was 78%, for non-urban sites 62%, and for the restored NCOS site 39%. Despite the urban mean being greater than the non-urban mean, the overlapping standard error bars on the bar graph qualitatively demonstrate that the PCCs of the urban and non-urban sites were not statistically significantly different. Although the standard error range spanning the mean PCC for the non-urban sites did not encompass the PCC value for the NCOS site, the PCC value for the NCOS site was closer to the mean PCC value for the non-urban sites than that of the urban sites.

The NCOS PCC value was the lowest value and closer to the mean non-urban PCC value than the mean urban PCC value. Based on the results of this study, it is suggested that more trees or other vegetation be planted at the NCOS restoration site to make the projected NCOS PCC value closer to the mean PCC value of the non-urban sites.
